Procedure for Re-Engaging a Misaligned Double Dog Gear

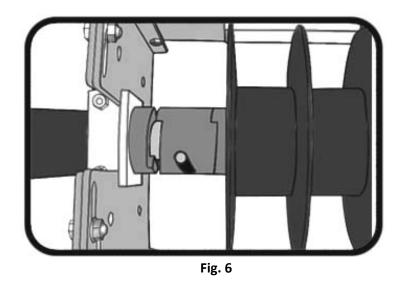
Step 4: Run the motor to engage the Double Dog Gear on the opposite side *(the side nearest the Rope Reel)*. The Gear should push the mechanism into its correct. Watch for a clean and tight engagement. **Fig. 6**, below, shows a correctly engaged Double Dog.

Step 5: Level the mechanism. A balanced and level Infinity 4000[™] will be less likely to come out of alignment. With the unit balanced and the gear engaged, secure any bolts that have been loosened. Test the unit by operating the cover back and forth several times.
